Mr. Lee Heeren  
Illinois Environmental Protection Agency  
4302 North Main  
Rockford, Illinois 61103  
Subject: EPA Oversight Inspection Report

**CWA OVERSIGHT INSPECTION REPORT  
ILLINOIS**

<b>Inspection facility</b>	Golden Oaks Farm 27730 W. Bonner Road Wauconda, IL 60084
<b>NPDES permit status</b>	No permit
<b>IEPA inspection date</b>	05/02/12
<b>EPA inspection date</b>	09/05/12

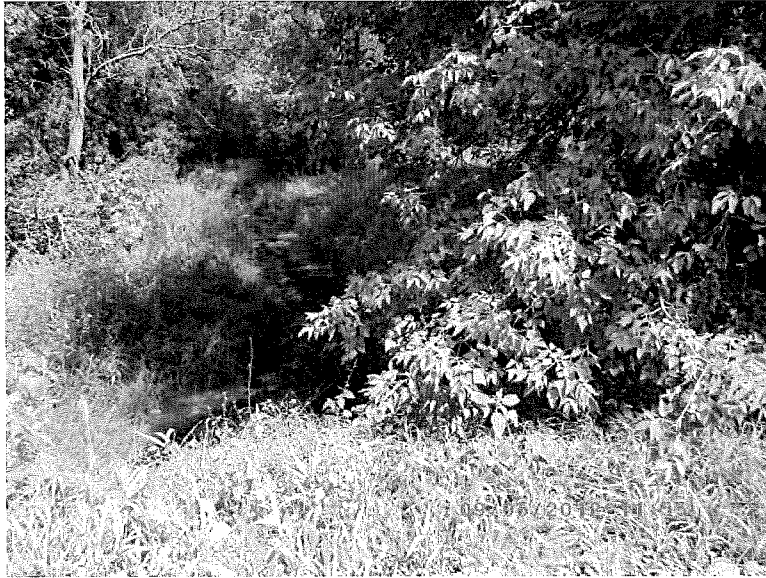
IMGP1436: Crossing Mutton Creek along facility access road. There was water in Mutton Creek on the day of the inspection.

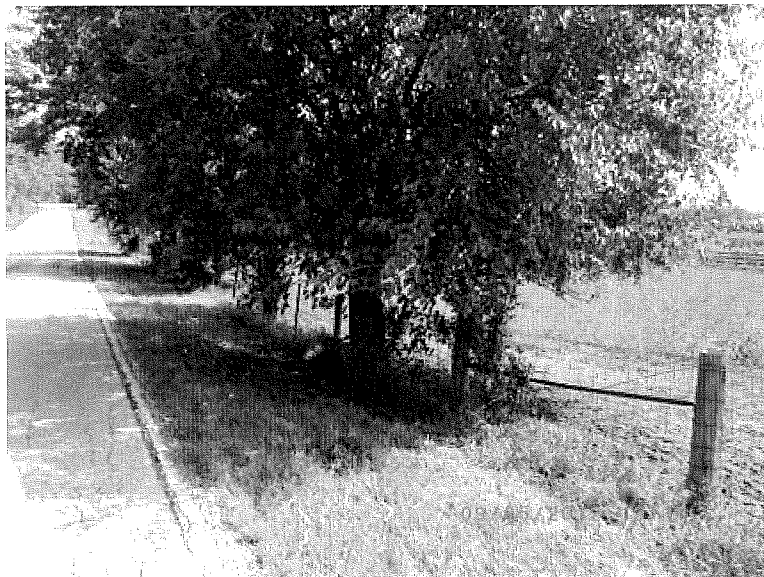
IMGP1444: Roadside ditch along Neville Road has no culvert. Lowest point is just north of walkway. Any runoff would not leave the property.  
 Location: North of Whipple Farm  
 Facing: Southeast  
 Date/Time: 09/05/12 12:18 P.M.

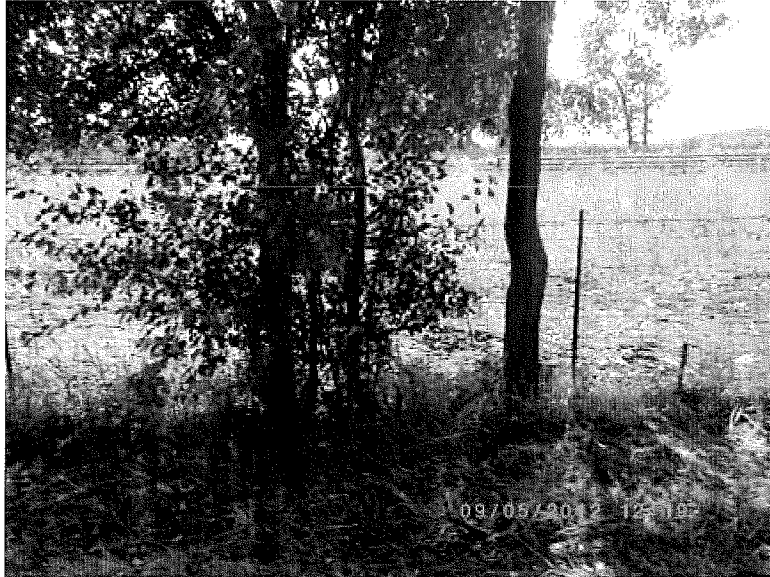
IMGP1445: Lowest point along Neville Road.

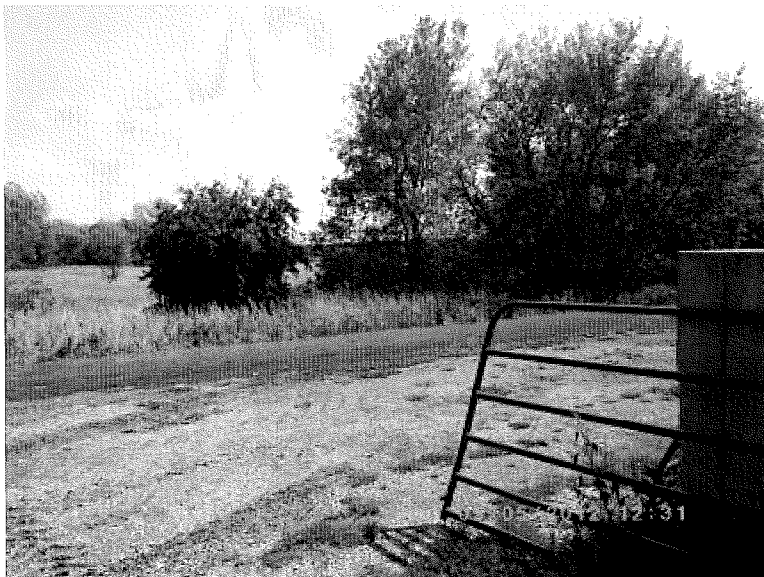
IMGP1460: Runoff from concrete pad would flow to vegetated area to the north and east.  
 Location: Northeast corner of Darrell Road Facility  
 Facing: Northeast  
 Date/Time: 09/05/12 12:31 P.M.

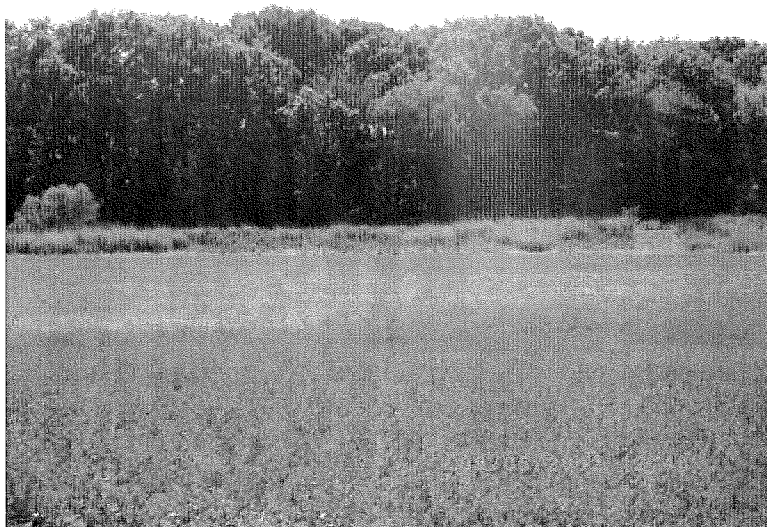
The inspection continued at the Silage Pad of the Dairy, passing through the Compost Facility on the way. The Silage Pad is on the north end of the Dairy. EPA observed silage leachate pooled in the northwest corner of the Silage Pad and a channelized pathway of silage leachate leading to the west to a Vegetated Filter. After approximately 30 feet, the channelization of the leachate was not present anymore. Mr. Patterson stated

IMGP1462: Runoff from Silage Pad flows to a vegetated filter to the west.

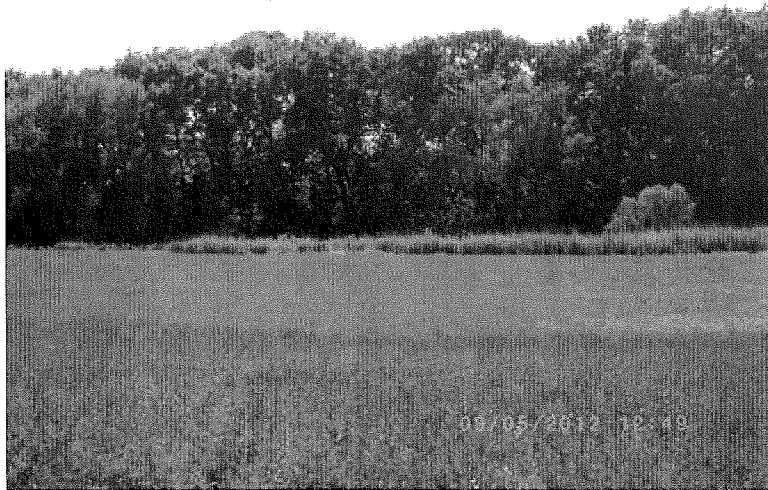
IMGP1463: Runoff from Silage Pad flows to a vegetated filter to the west.  
Location: Northwest corner of Silage Pad  
Facing: West  
Date/Time: 09/05/12 12:49 P.M.

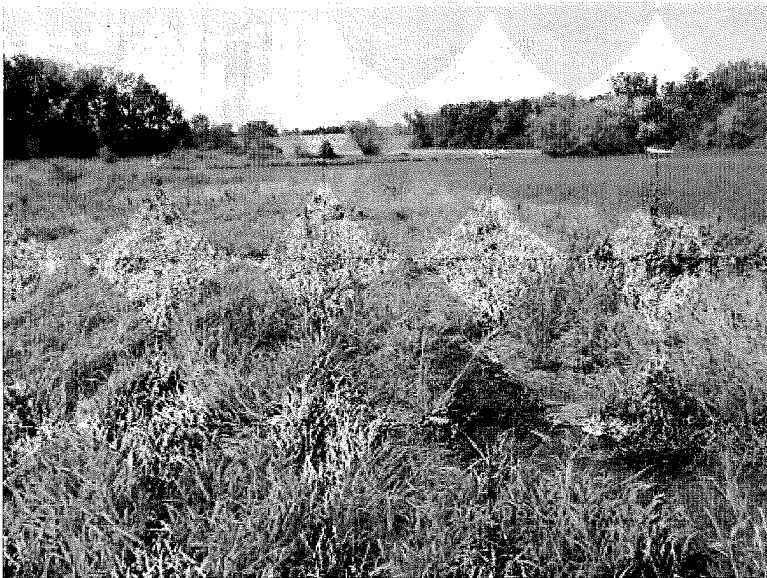
that he had never seen the Vegetated Filter completely full with precipitation. EPA discussed with Mr. Patterson that although silage leachate flows to a vegetated filter, during periods of heavy precipitation, if the vegetated filter overflowed to Mutton Creek, the presence of silage leachate in that water would be considered a discharge.

IMGP1466: Silage leachate pathway to vegetated filter.

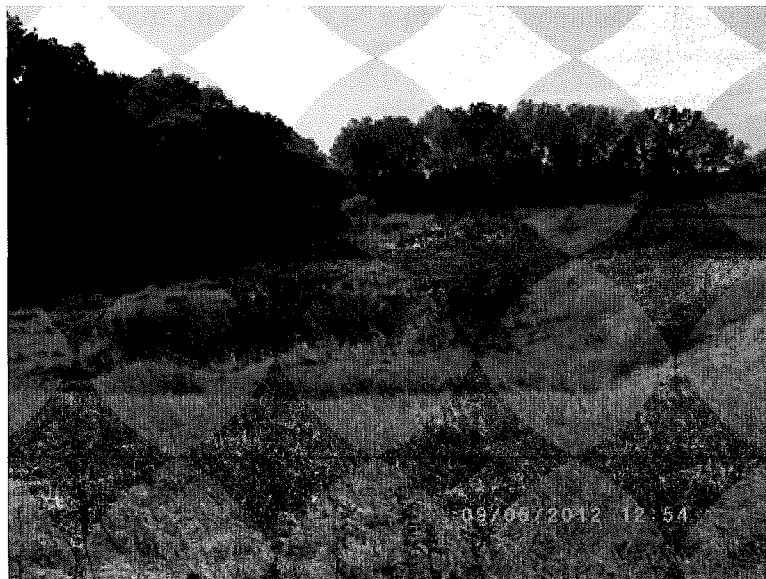
IMGP1468: Facility reports that vegetated filter area never fills up.

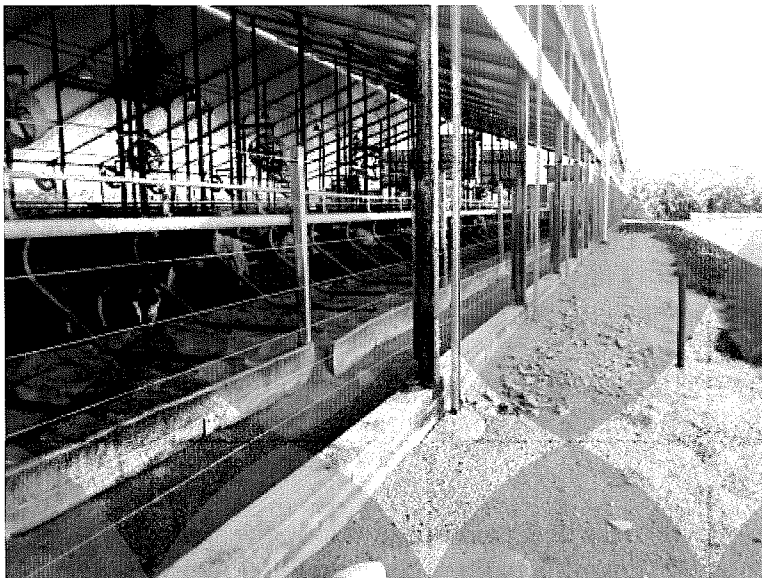
IMGP1480: Some push out of sand from the North Barn.

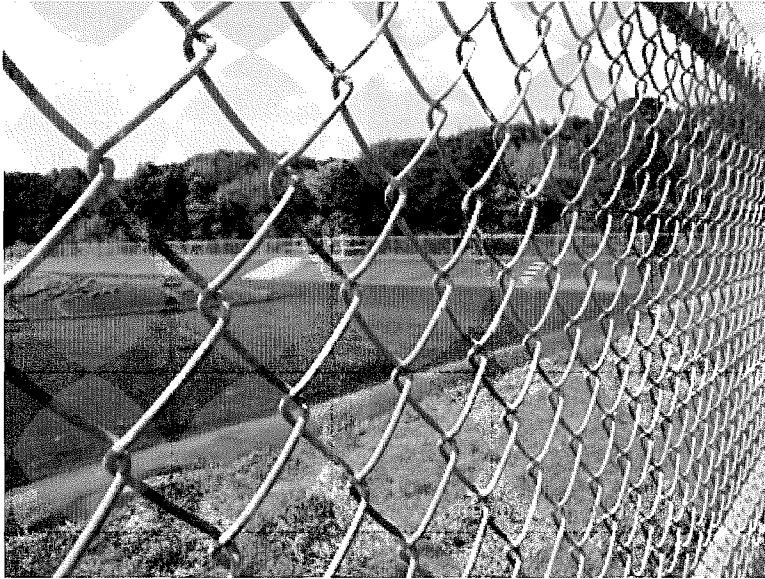
IMGP1482: Manure Pond has fence around its entirety.

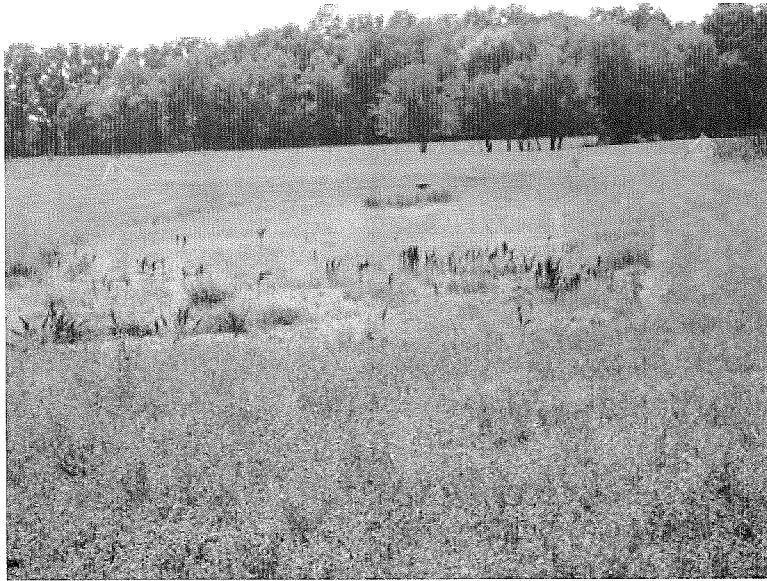
IMGP1490: Clean water detention basin.

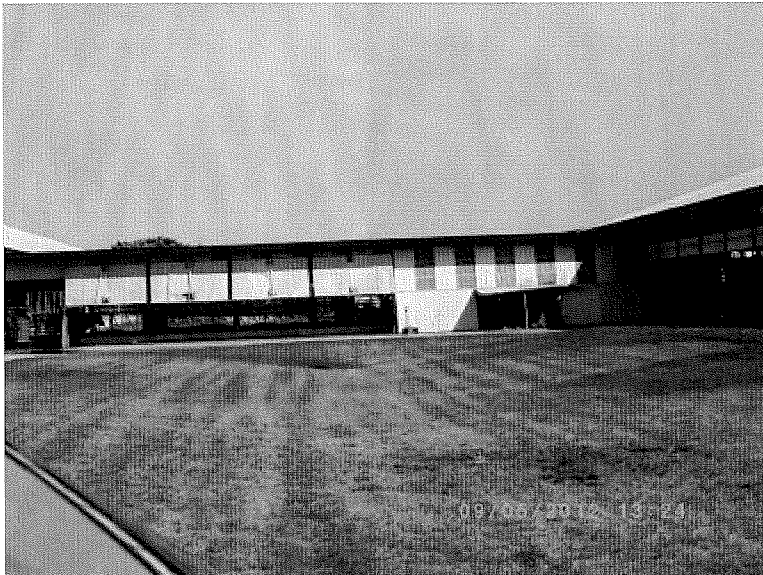
IMGP1491: Between the North and South Barns. Storm water flows to a manhole in center of yard and is piped to the west.

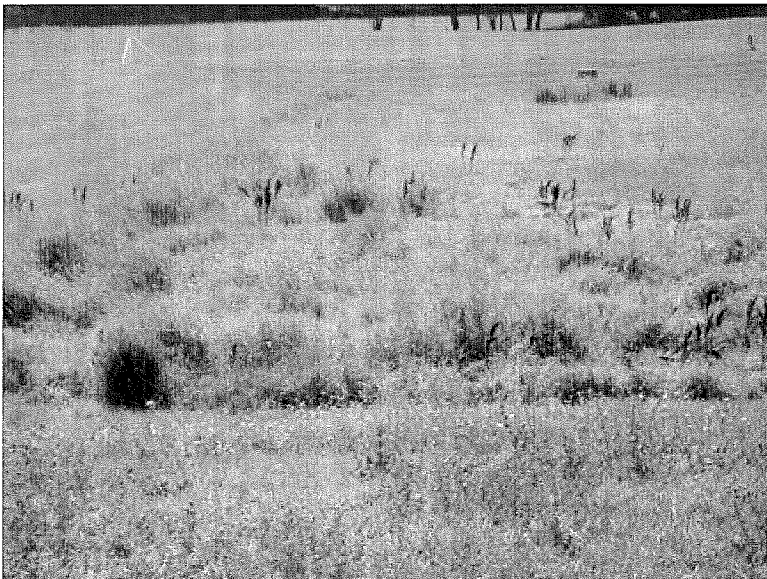
IMGP1493: Clean water basin on west side of facility.

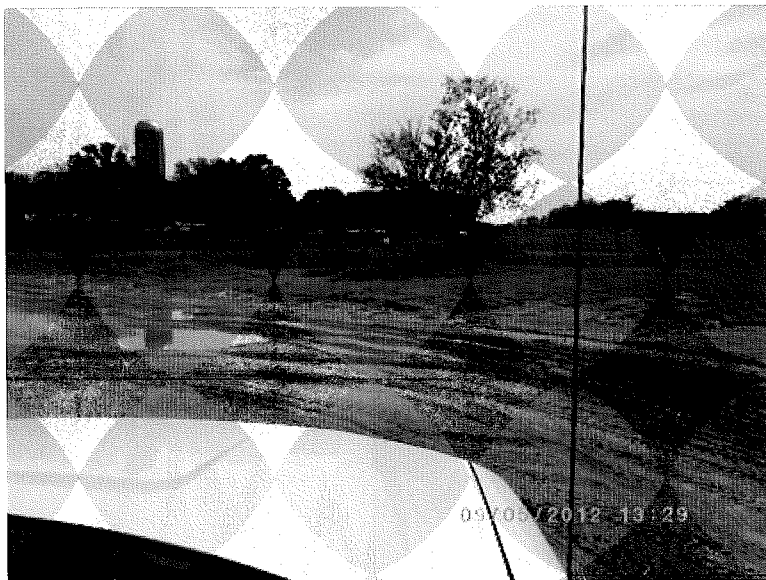
IMGP1495: Old Main Barn area to the south.

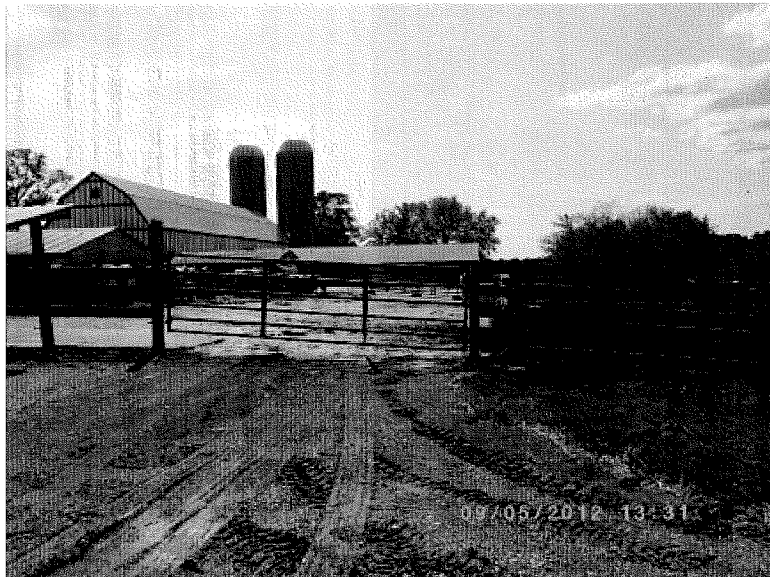
The Old Main Barn at the south end of the Dairy houses approximately 35 dry cows. Open lots attached to the barn are scraped and no runoff or discharge was observed on the day of the inspection.

IMGP1497: Old Main Barn contains approximately 35 dry cows.

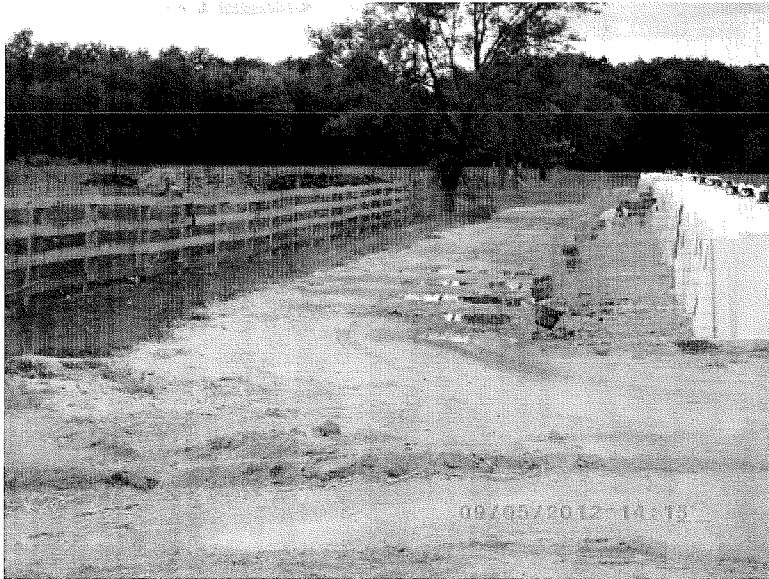
IMGP1500: 24 additional Calf Hutches located north of the Heifer Barn.

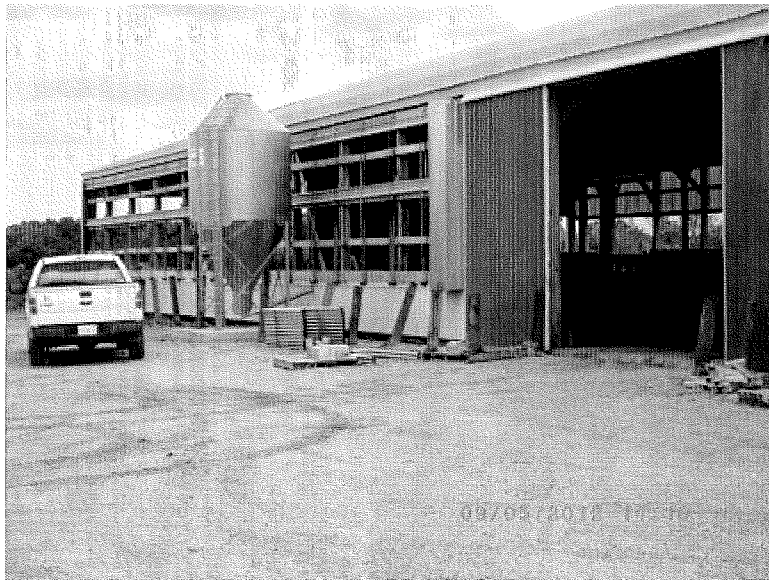
IMGP1501: North side of Heifer Barn.

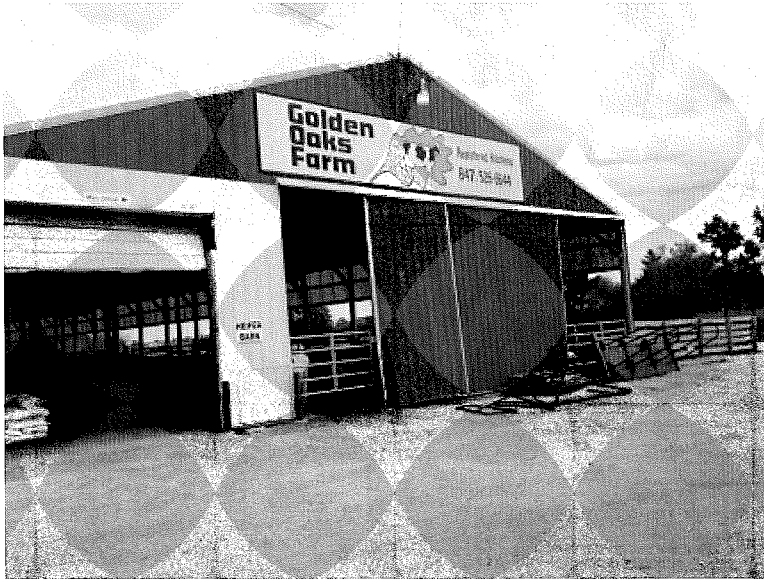
IMGP1502: Golden Oaks Farm Heifer Barn.

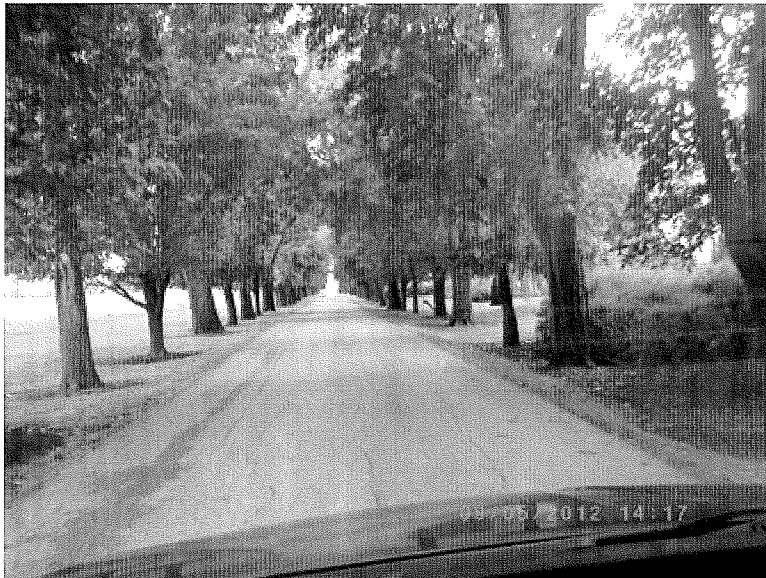
IMGP1505: Main road from dairy to Bonner Road.
